**Second  
International Conference  
on  
Case Histories in  
Geotechnical Engineering**

**June 1-5, 1988**

**University of Missouri-Rolla  
Rolla, Missouri**

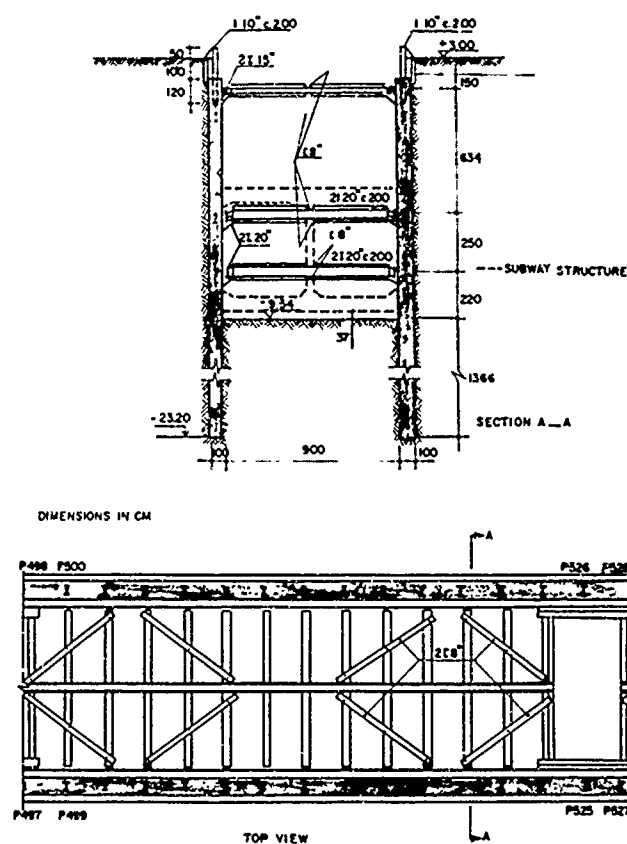
Fig. 4. Rio de Janeiro Subway Retaining Structure at Catete Street

The retaining structure for the excavation slopes consisted of vertical walls supported laterally by three levels of struts that can be seen in Figure 4 where a cross-section and a top view of the retaining structure is presented. Slurry trench (diaphragm) walls incorporated to the final structure of the subway tunnel were used on these retaining structures (Xanthakos, 1979 and Hajnal et al., 1984).

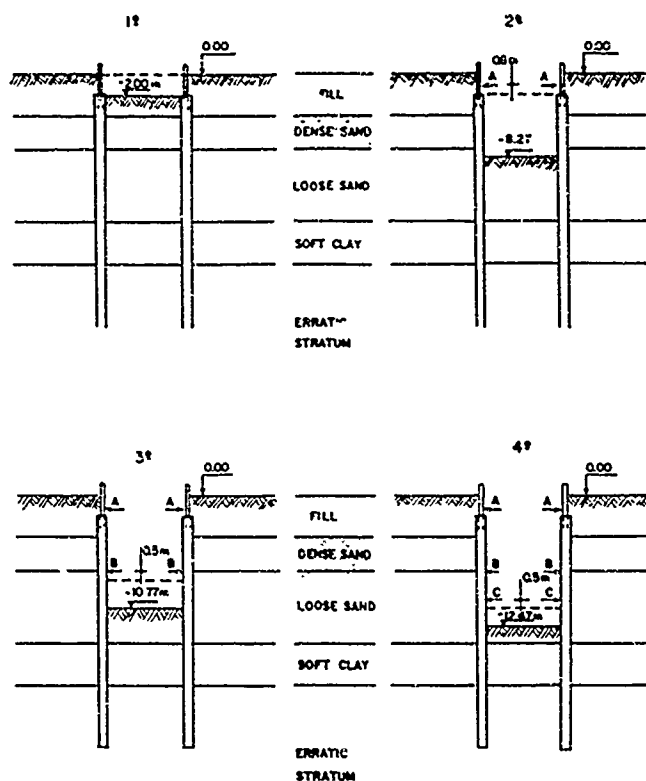
Fig. 5. Excavation Steps

The excavation was executed in four steps as shown in Figure 5. Steps 2, 3 and 4 consisted of first installing struts A, B and C, respectively, and then, excavating.

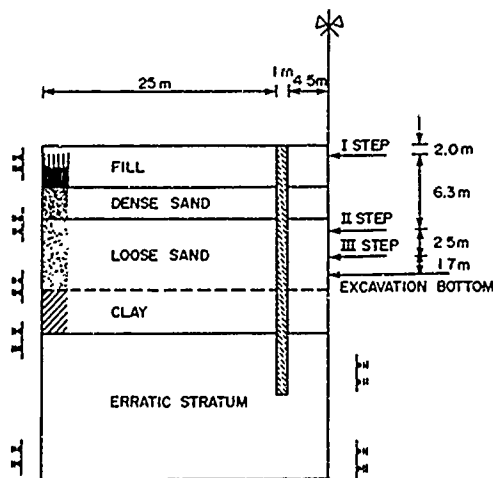
Fig. 7. Problem Idealization

The numerical analysis was performed using a finite element program, FENA-2D (Krishnayya, 1973), available at the time. The real problem was idealized as shown in Figure 7 and numerically solved using the mesh presented in Figure 8.

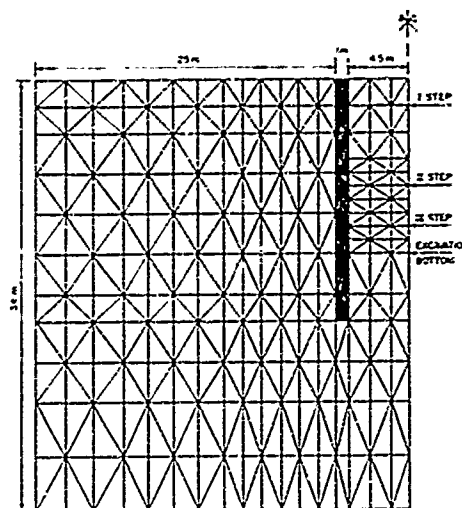
Fig. 8. Finite Element Mesh. 403 Elements and 233 Nodal Points

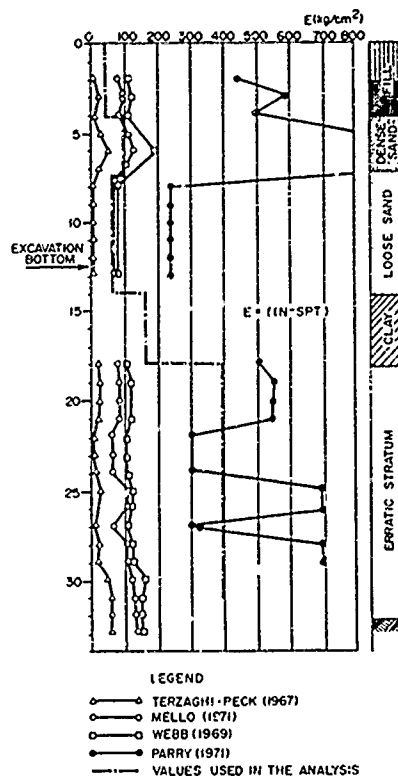
Fig. 9. Elasticity Modulus Correlation

The elasticity moduli ( $E$ ) used in the analysis were obtained for each layer averaging values obtained with different correlations with  $N(SPT)$  (Terzaghi and Peck, 1967; Webb, 1969; Parry, 1971 and Mello, 1971) and the laboratory test results (Figure 9).

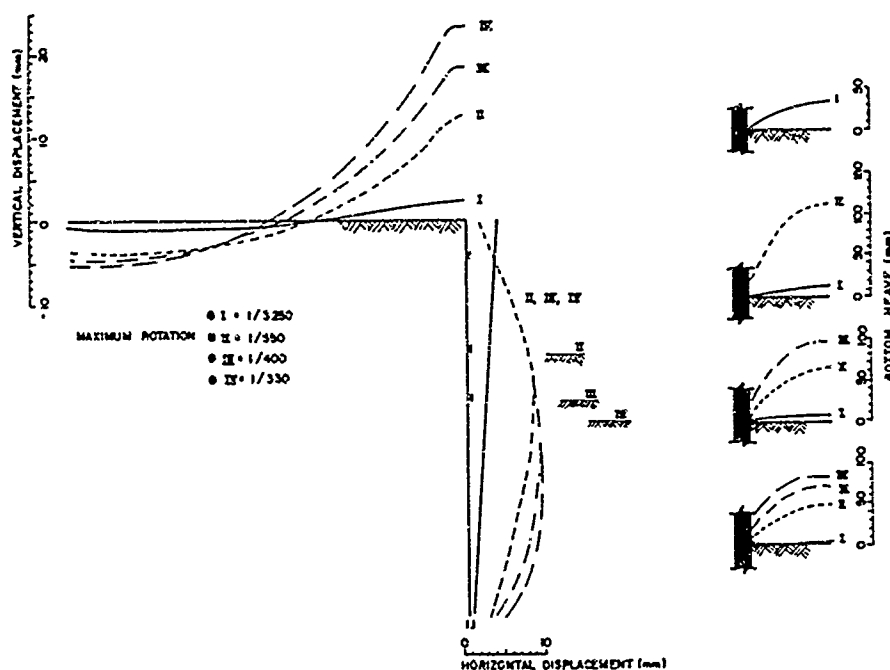
Fig. 10. Analytical (Numerical) Displacements

Figure 10 shows vertical displacements of surface points near the excavation, together with the lateral movement of the diaphragm wall and the bottom heave, for each excavation step. As can be seen the vertical settlement was much smaller than the ones measured in building number 186 (Figure 6). There are many reasons to explain this difference. First, the use of linear elasticity disregards any decrease

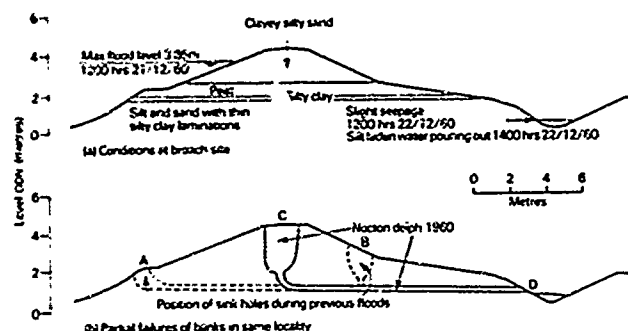
Fig 2 Underseepage failures of banks built on laminated clayey, silty, sandy deposits in the Lincolnshire Fens.

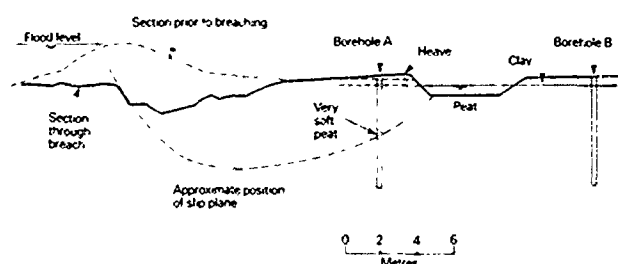
Fig 4 Section through centre line of breach shown in Fig 3.

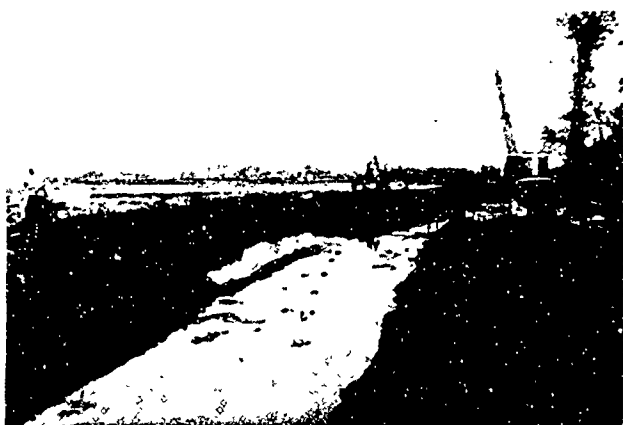
Fig 5 Photograph of lateral displacement bank built on peat (Somerset Levels)

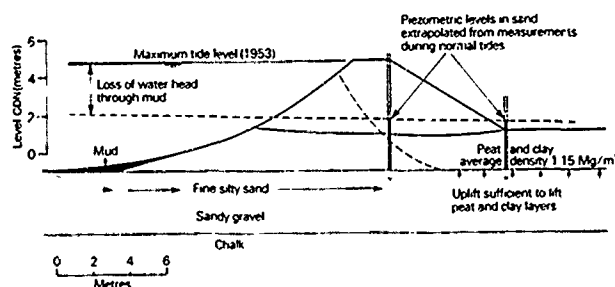
Fig 6 Section through breached bank near Dartford Lock, Kent.

The breach occurred at a locality where the thickness of the peat and clay was only 1.8 metres as shown in the section in Fig 6. Direct extrapolation of pore pressures measured in the gravel near the breach side over normal tides indicated that floatation of the peat and clay in the marsh had probably occurred before the bank failed. Effective stress analyses confirmed that the bank could have slipped into the marsh under these conditions as indicated in Fig 6. It should be noted that the pore water pressure response in the gravel near the bank was only about 25% of the tidal range in the river due to the presence of a 200 mm thick layer of mud which covered the bed.

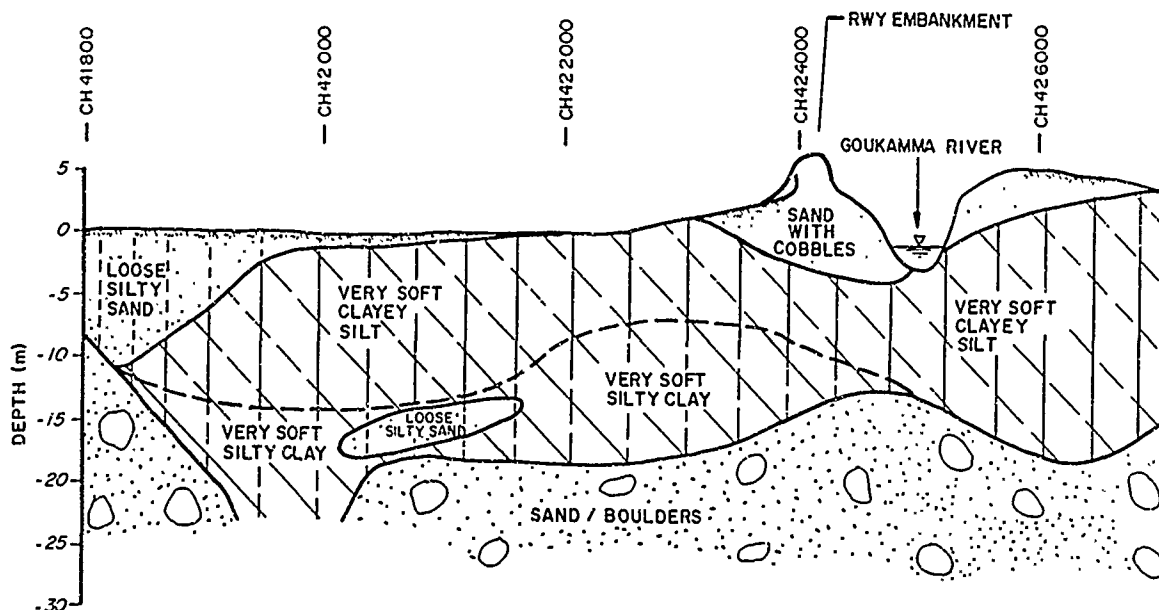
Fig. 2 Soil Profile Along Embankment Centerline

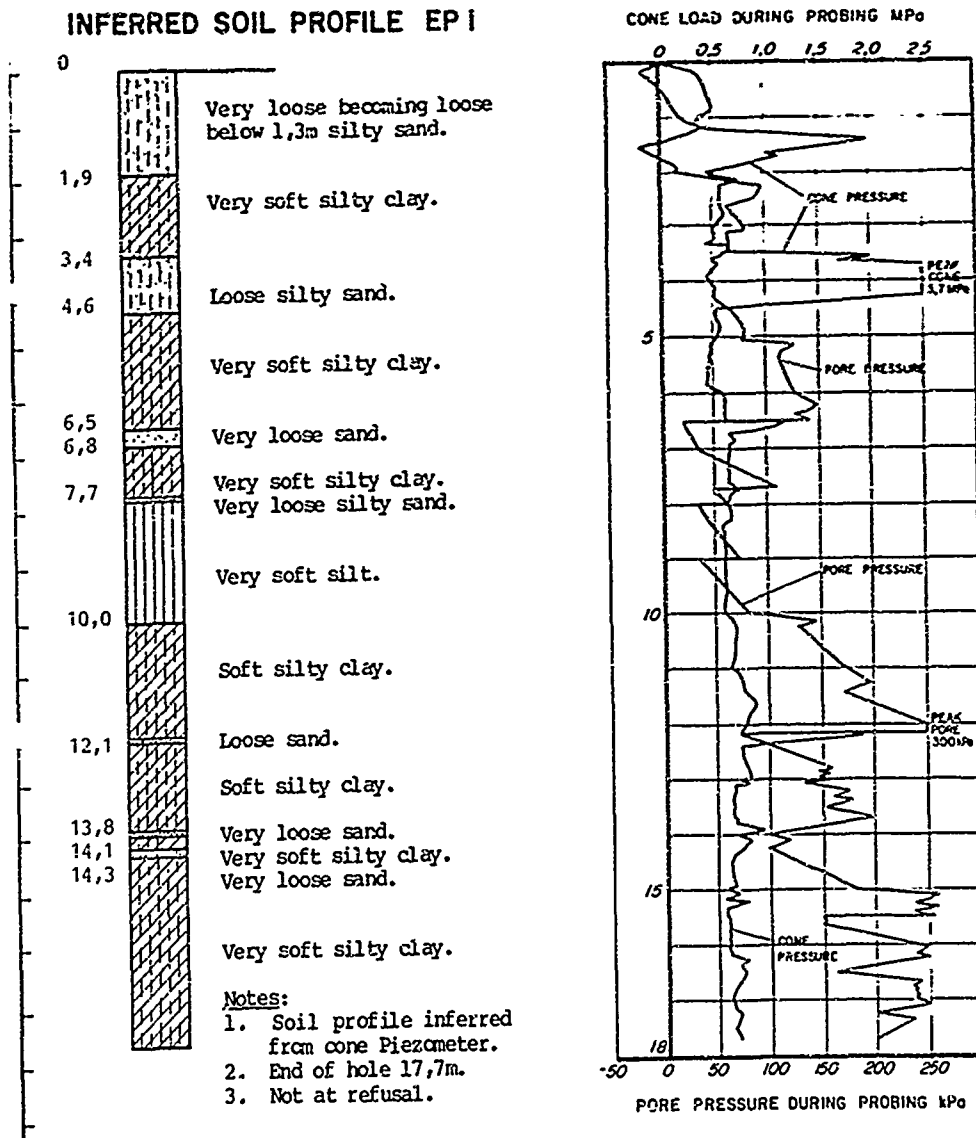
Fig. 3 Typical Piezocone Record - Area C

A typical piezocone record from area C is shown in Figure 3. The existence of organic and/or sandy lenses can be seen from the pore water pressure record. From the point load data the value of undrained strength of the clayey silt was observed to generally be in the range of 10 to 15 kPa. The shear strength typically appeared to be uniform with depth.

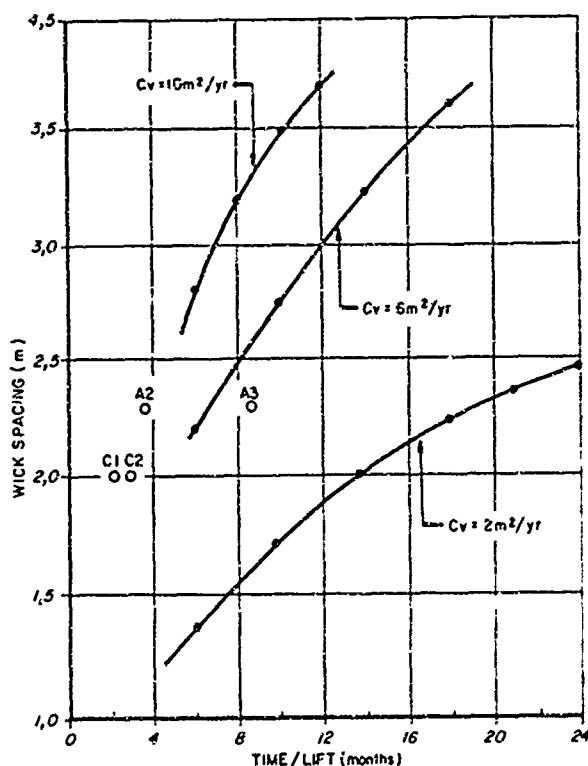
Fig. 4 Effect of Band Spacing on Times for Pore Pressure Dissipation

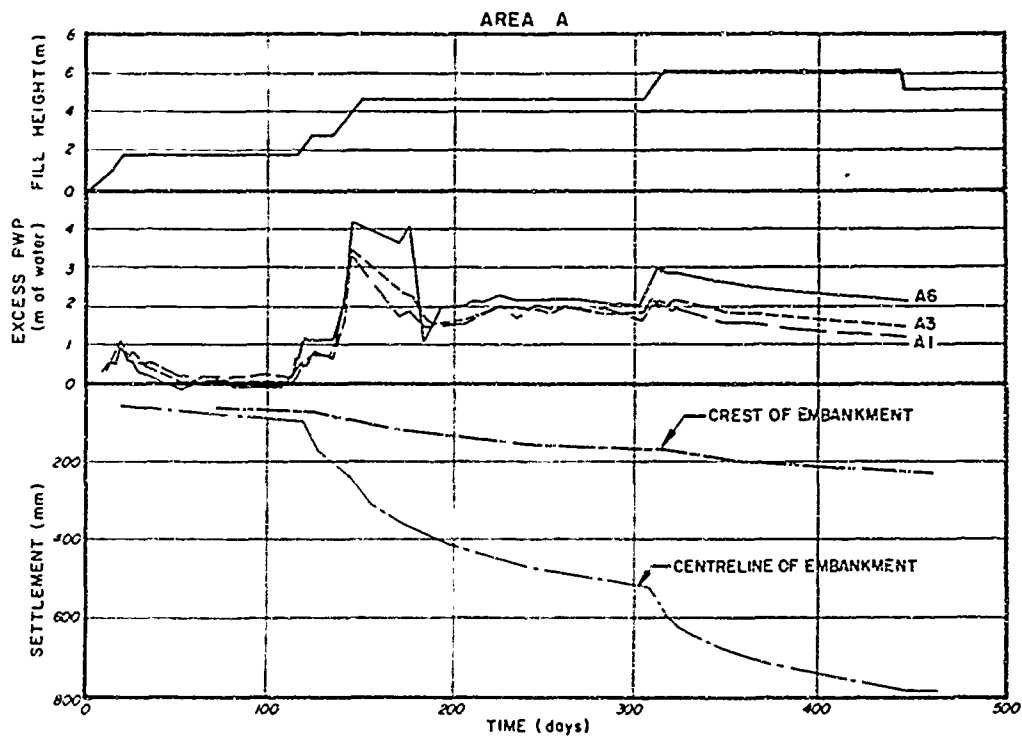
Fig. 6 Loading History, Piezometer Response and Settlement - Area A

The first lift of the embankment consisted of the drainage blanket. After 120 days a second lift was placed and a third lift was placed at about 300 days. The loading sequence is shown in Figures 6 and 7.

The loading history and the piezometer responses are shown on Figures 6 and 7. In area A the piezometer showed an almost immediate response of approximately 70 to 80 percent of the applied surface load. In area C the response was very close to 100 percent of the applied load.

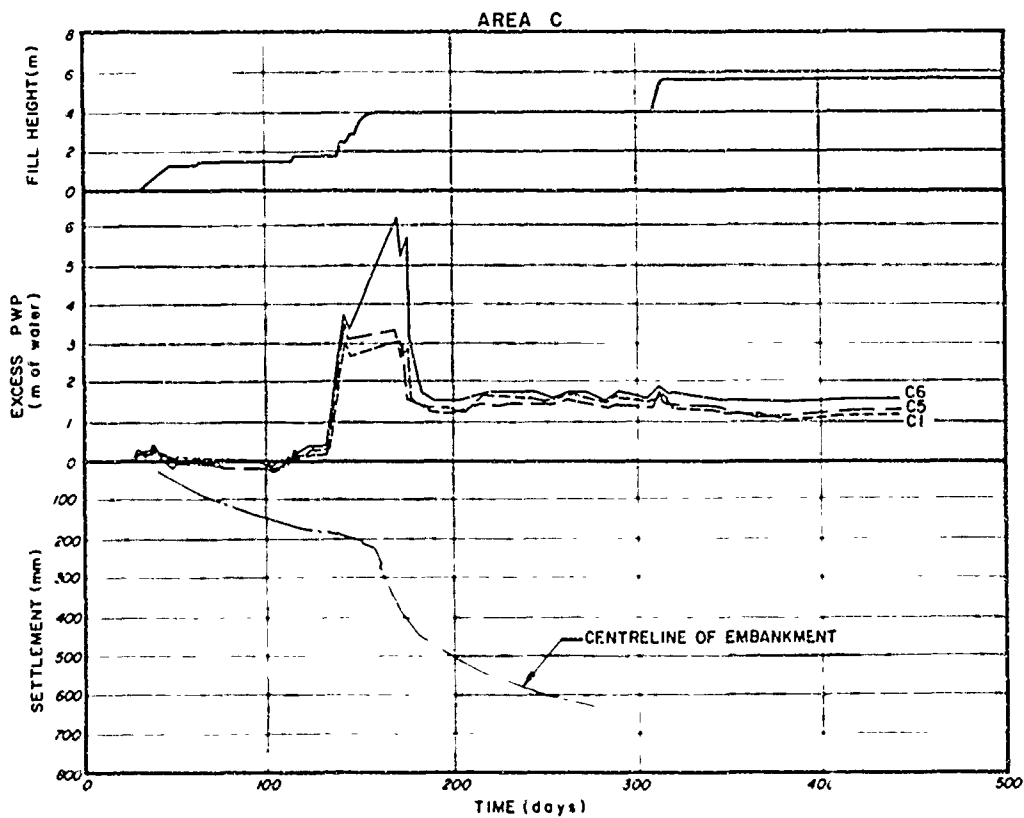
Fig. 7 Loading History, Piezometer Response and Settlement - Area C

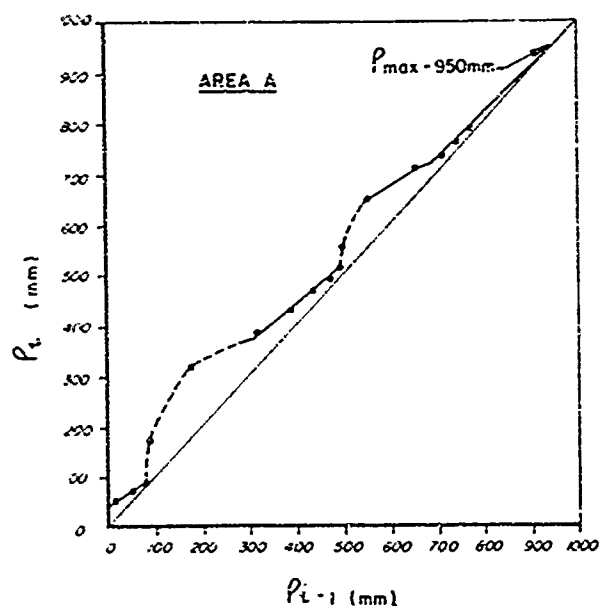
Fig. 8 Plot of Consolidation Data

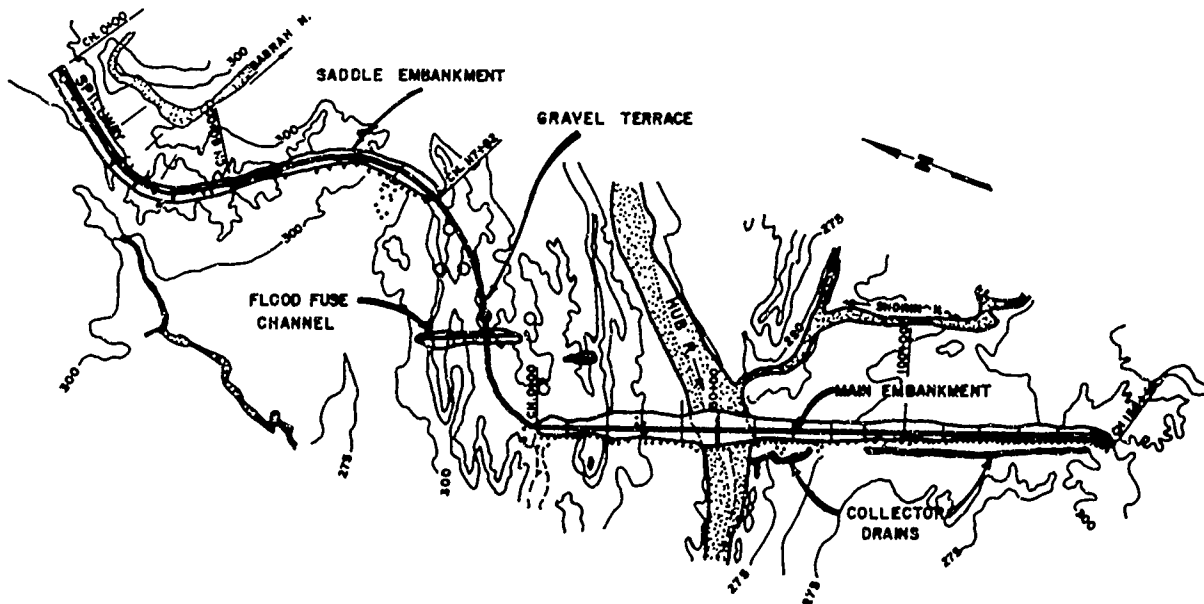
FIG.1 HUB DAM PROJECT - LAYOUT PLAN

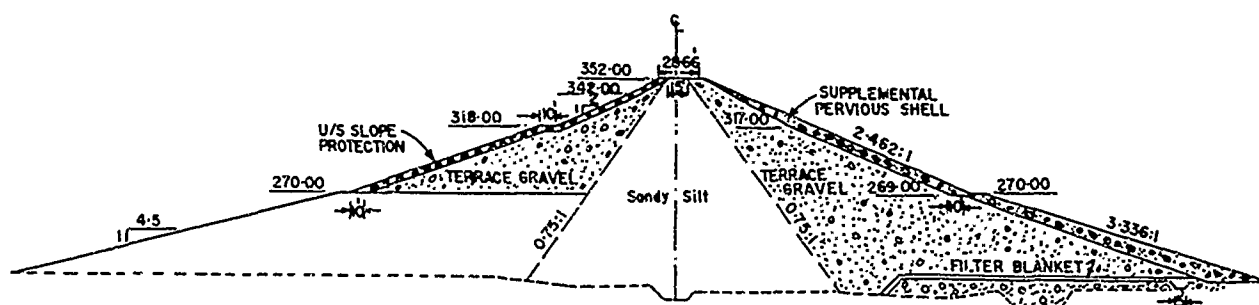
FIG. 2 HUB DAM - TYPICAL ZONED SECTION

terrace gravel shoulders in the closure section, Fig. 2.

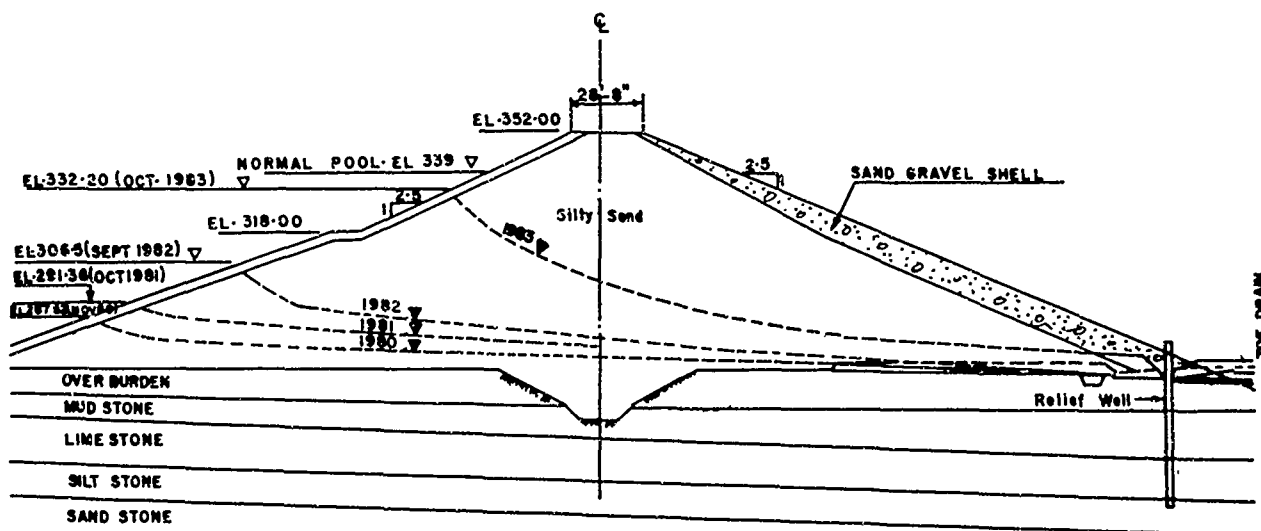
FIG.3 HYDRAULIC GRADIENTS AT DIFFERENT IMPOUNDINGS

The summer impounding of 1983 produced a reservoir rise of 34.25 ft when water level touched El 333.65 i.e., 5.35 ft short of full pool level El. 339. The response of the toe instruments in limestone zone was about the same as in 1982. The toe instruments at Ch 78-79 registered piezometric rise upto 14.94% against preceding year's 19.6%. Thus the rate of rise of hydrostatic pressures at the dam toe either decreased or generally remained the same, showing continued effectiveness of relief wells during successive reservoir fillings. Comparative gradients of hydrostatic pressures in the dam foundation in the above reach during different impoundings are shown in Fig.3.

It was therefore decided to add a supplemental sand-gravel shell as shown in Fig.3 to enhance the stability of the downstream slope to acceptable limits under the particular conditions mentioned above. The shell was eventually constructed by selective borrowing of locally available river-run sand-gravel of required permeability without processing. The material, comprising upto 60% sand and rest gravel, was hauled by dumpers and trucks, placed and compacted to more than 70% relative density in lifts upto 18 inches using vibratory rollers. A protection layer of cobbles and boulders was provided over the shell slope.

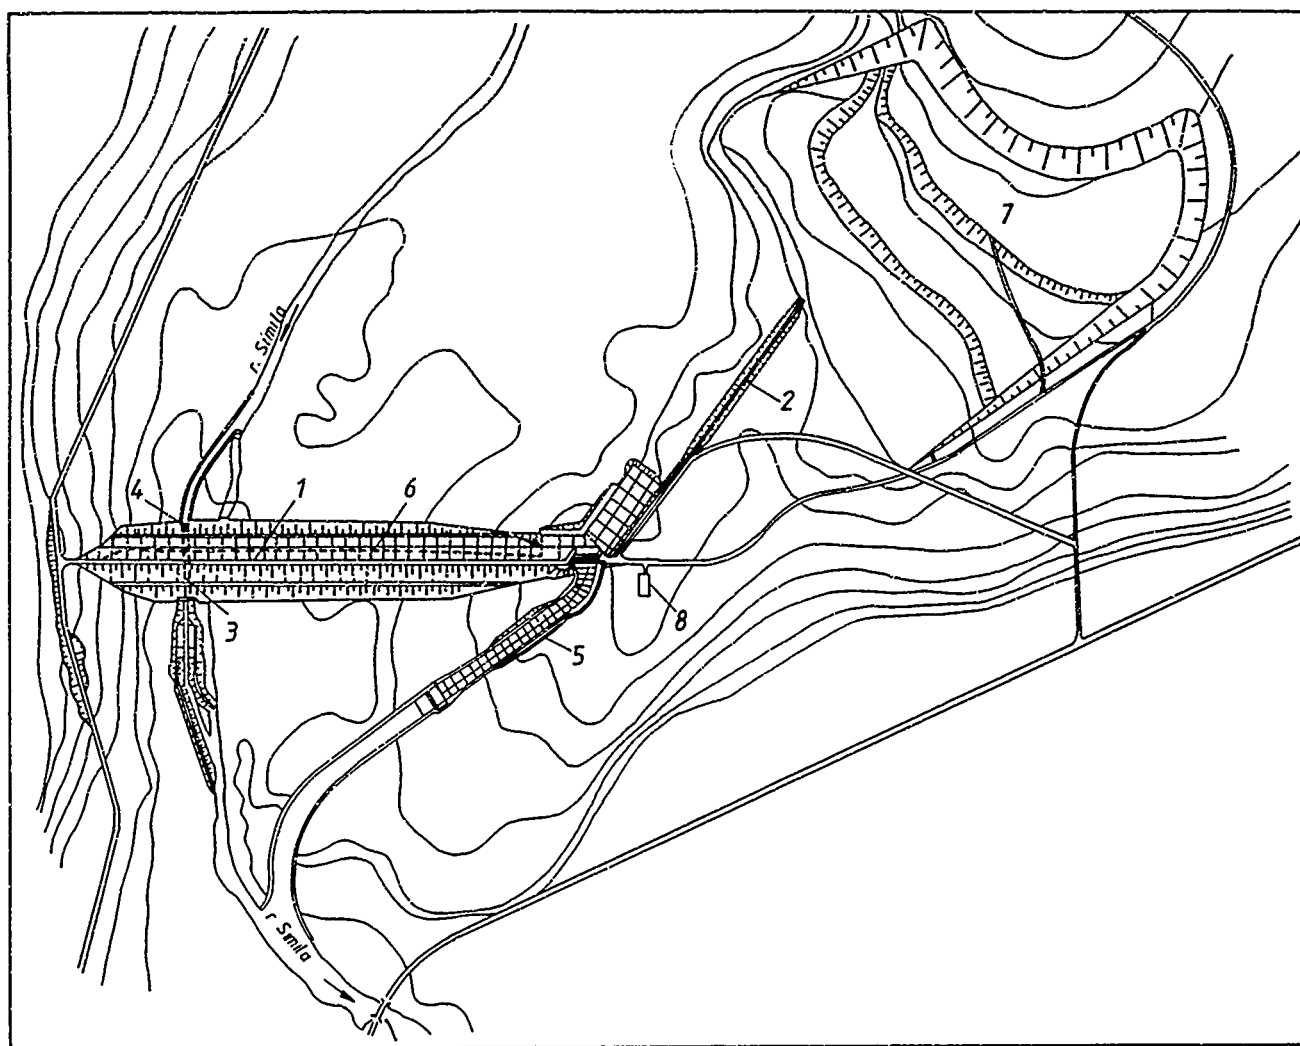
Fig. 1 Lay-out of Ripa Albastră Dam and Auxiliary Structures Location

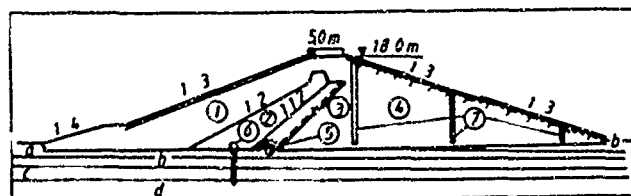
Fig. 2 Cross section of the Rîpa Albaştră Dam  
1 Upstream prism a Clayed sand  
2 Core (sand with bentonite) b Clay  
3 Filtering layer c Medium-fine sand with gravel

- 4 Downstream prism d Earley clay
- 5 Longitudinal drain
- 6 Cut-off wall
- 7 Piezometers

Field and laboratory research revealed as the most favourable source of local materials for dam fillings, the fine-medium sands of the kersonian-moşian complex, occurring mainly in the left slope of the reservoir, exceeding 15 m. in thickness. From the quarry located about 1 km upstream of the dam site, covering a surface area of 3.3 ha, some 650,000 cu.m. fine-medium silty-sands were exploited, with natural water content values  $w = 7-10\%$ , degree of saturation  $S_r = 0.2-0.5$ , and natural volume weights of  $\gamma = 16-19.5$  kN/cu.m. Following laboratory compaction tests (PROCTOR), it was observed that sands compacted at natural water content with mechanical efforts  $E_f = 4-6$  dJ/cu.cm. can reach minimum dry volume weights of  $\gamma_d \geq 16.5$  kN/cu.m, shearing indices of  $I_p = 25-30\%$ ,  $c = 0.1-0.15$  daN/sq.cm, and permeability coefficients of  $k = 10^{-7} - 10^{-6}$  cm/sec. The relatively high values of permeability entailed the adoption of nonhomogeneous section dam, with an impervious core inclined towards the sandy supporting prisms, Figure 2

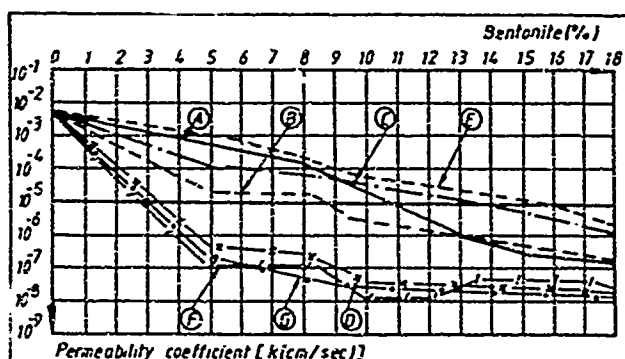
Fig. 3 The Variation of the Permeability Coefficient of Compacted fine-medium Sands with Gravel Depending on the Various Percentage of A-G Bentonites.

Figure 3 presents as an example the variation of the permeability coefficient of a fine-medium sand with gravel, compacted at 6 dj/cu.cm. efforts, with various percentages of A-G bentonite.

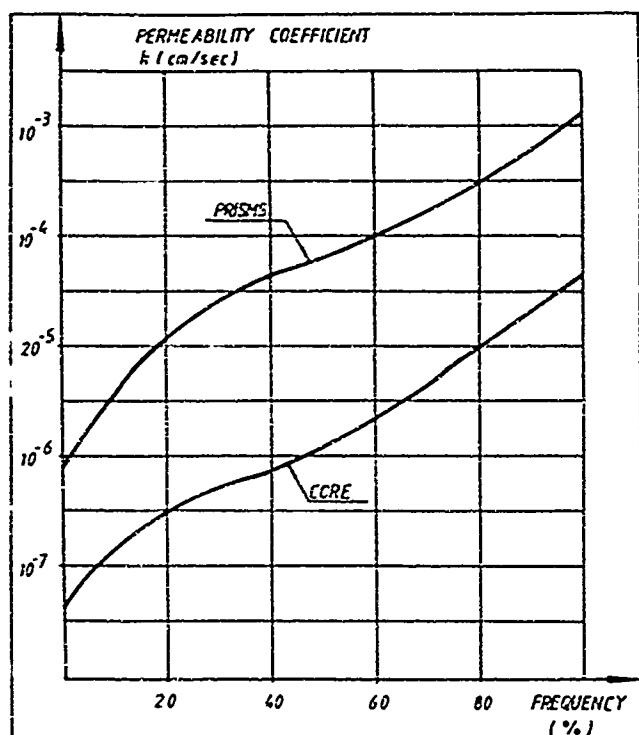
Fig. 5 The Variation of Core and Prisms Permeability of Rîpa Albastră Dam

The degree of core embankment compaction (about 72,000 cu.m.) was checked by the laboratory analysis of about 2,000 samples taken by the contractor from each layer and by 8" diameter control boreholes drilled in three different stages. The statistical processing of the dry volume weight values ( $\gamma_d$ ) obtained in the core, revealed the variation of this index according to the law of normal distribution, resulting in a mean square distortion of  $\sigma = 0.166$  and an average of  $\gamma_d = 18.045$  kN/cu.m. Under these circumstances the degree of compaction attained was 98 - 100%. The bentonitic core permeability compared to that of the sandy supporting prisms (upstream and downstream) was tenfold - hundredfold lower, the recorded values being  $6 \times 10^{-5}$  -  $7 \times 10^{-8}$  cm/sec, Figure 5.

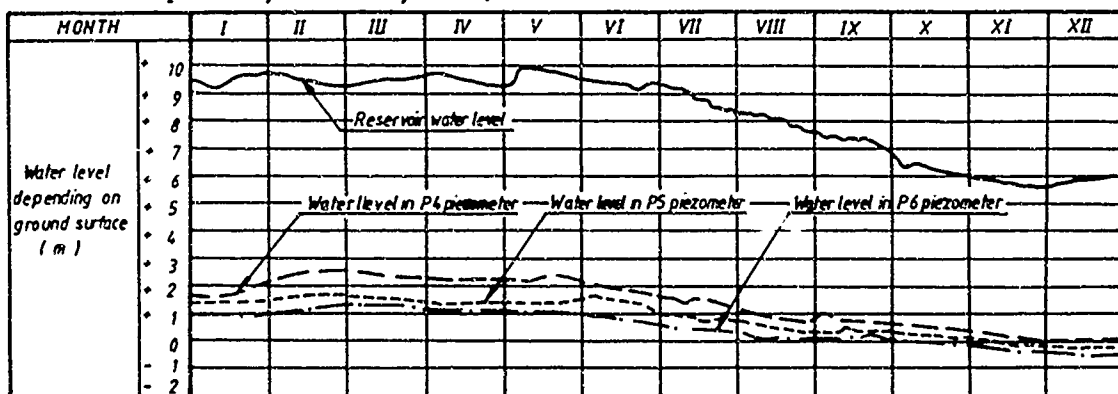
Fig. 6 The Diagram of the Downstream Hidrostatic Revels Recorded during 1986 Year.

Figure 6 presents as an example the diagram of the water levels in this prism, recorded in the central profile piezometer, during 1986.

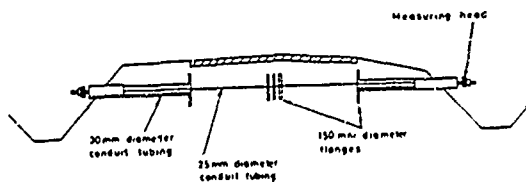
FIG 1. MEASUREMENT OF HORIZONTAL EDGE MOVEMENT OF THE ROAD SUB-GRADE RELATIVE TO THE ROAD CENTRE LINE

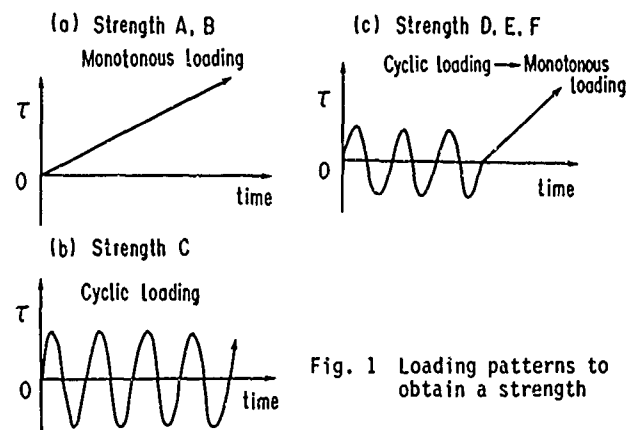
Fig. 1 Loading patterns to obtain a strength

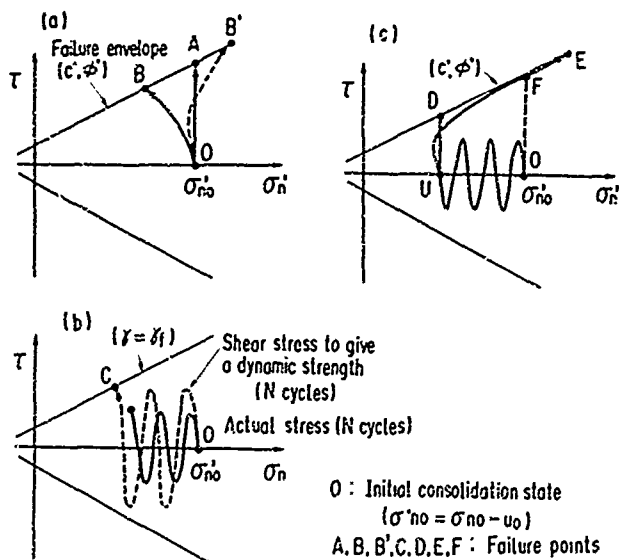
Fig. 2 Stress paths and strengths

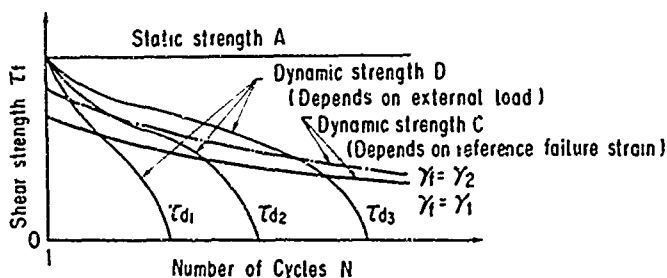
Fig. 3 Comparison of each strength

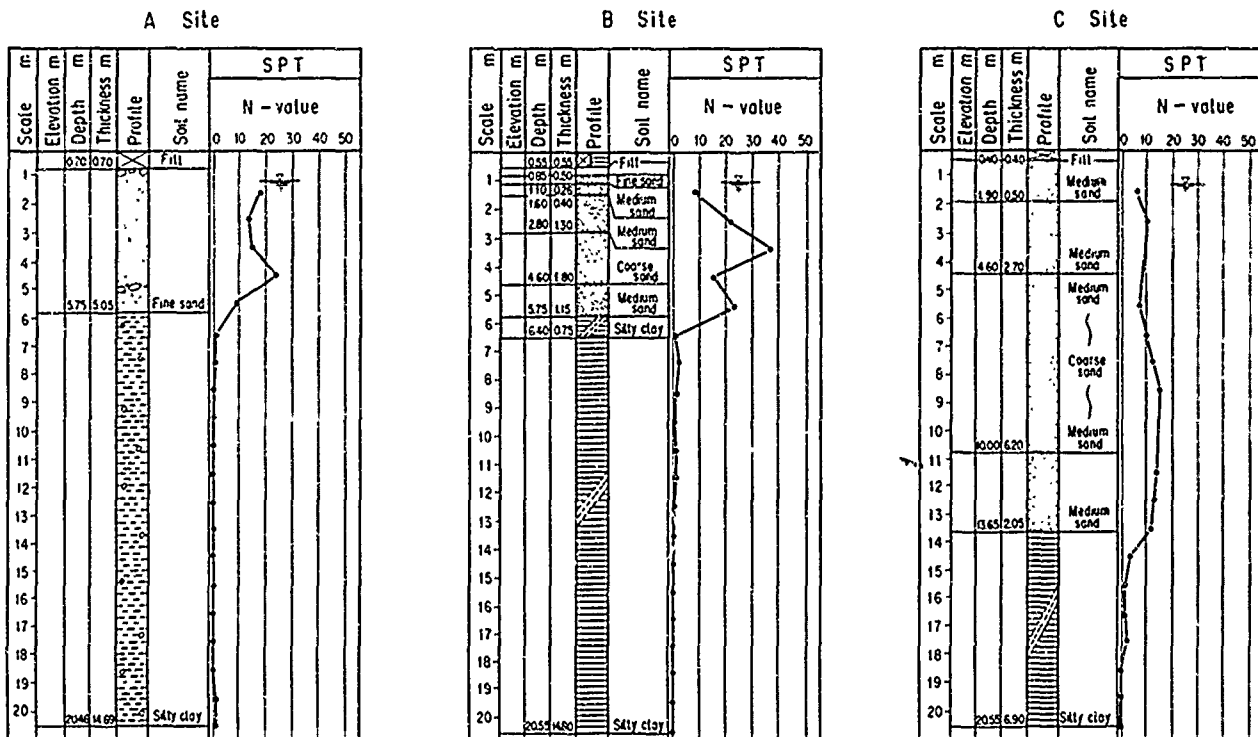
Fig. 5 Soil profile for each site

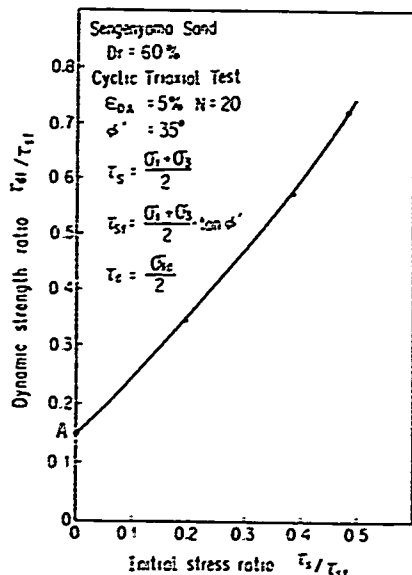
Fig. 6 Effect of initial shear stress on a dynamic strength

mainly assumed from existing data of another sand (Sengenyama sand) with similar gradation as this sand. Fig. 6 shows a main characteristic obtained in this manner. In this Figure, point A indicates a liquefaction

strength  $R_L$  without initial shear stress. The overall curve was vertically shifted to fit this point A to that of each site without changing the curve shape.

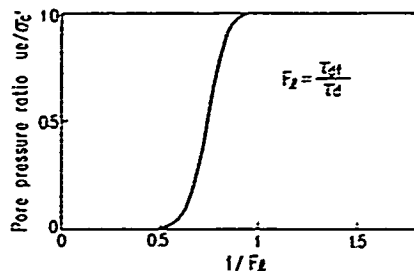
Fig. 7 Pore pressure generation characteristics

The characteristics of the excess pore pressure required to obtain a dynamic strength based on the excess pore pressure generated by a cyclic loading were obtained from cyclic triaxial tests of isotropically consolidated specimens. It is arranged as in Fig. 7.

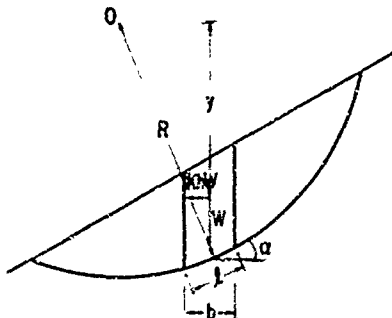
Fig. 9 Slip surface for seismic stability analysis

where  $c$ ,  $\phi$ ,  $\tau_f$  : cohesion, angle of shearing resistance and strength of soils respectively,  $u$  : pore pressure, see Fig. 9 regarding other notations.

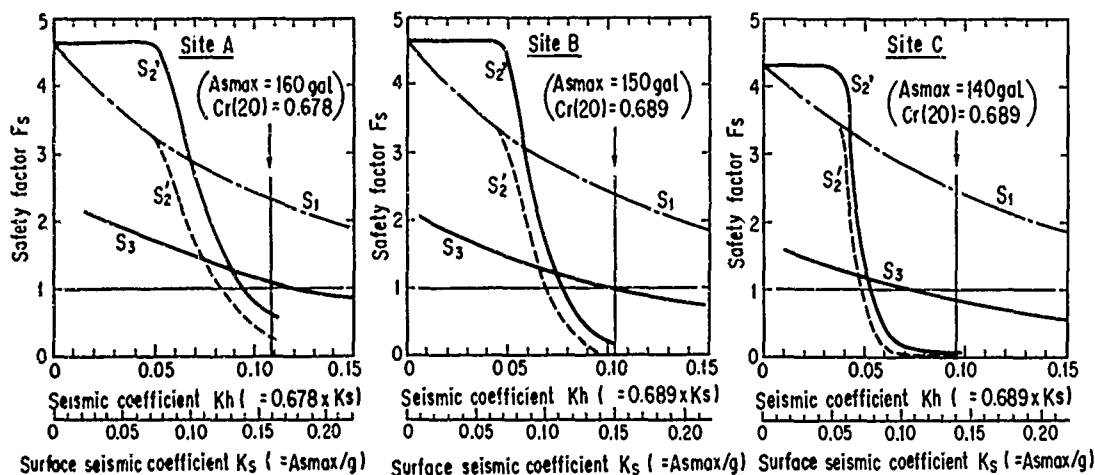
Fig. 10 Seismic coefficient vs. safety factor

Though the seismic coefficient at each site was already presumed, safety factors  $F_s$  for respective cases were calculated changing the seismic coefficient  $k_h$  0-0.3 in order to grasp the effect of  $k_h$  on  $F_s$ . The stability analysis results are shown in Fig. 10. Fig. 10 indicates the safety factor  $F_s$  depends much on the strength used. As regards both cases  $S_2$  and  $S_2'$ ,  $F_s$  decreases remarkably when  $k_h$  exceeds a certain value, which reflects that the excess pore pressure is very sensitive to the liquefaction resistance coefficient  $F_L$ .

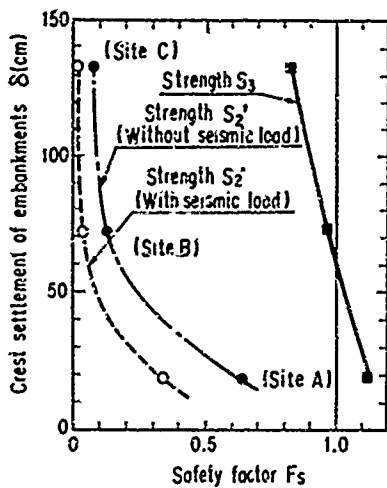
Fig. 11 Relation of safety factor vs. crest settlement

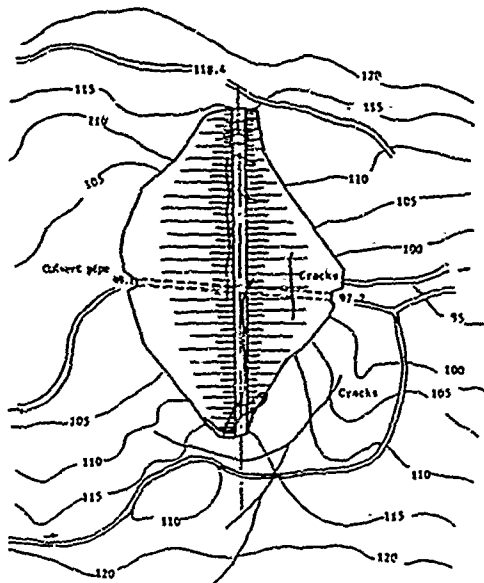
Fig. 1 Plan of Changmaidi earth dam

16 cracks were found on this dam after earthquake, mainly (12 cracks) along the abutments of dam (Fig. 1, 2 and 3). The width of cracks

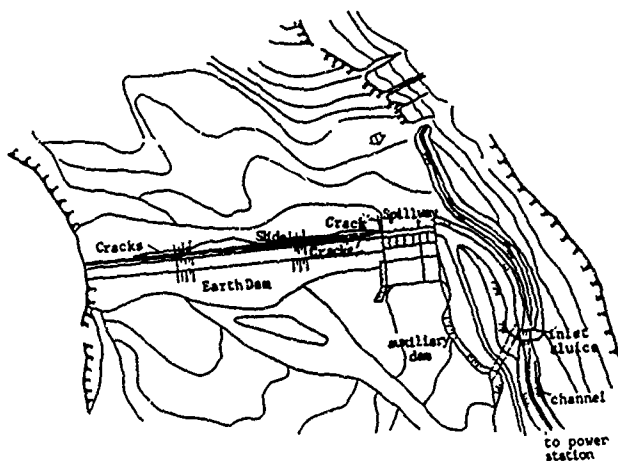
Fig. 4 Plan of Kashi hydroelectric power station

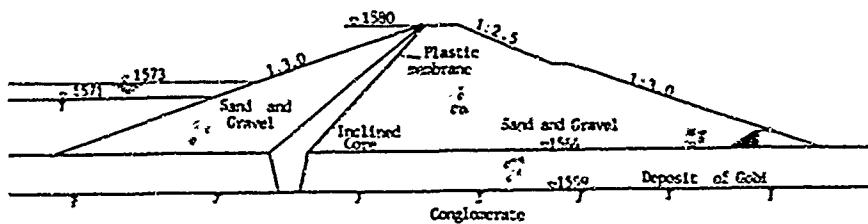
Fig. 6 Cross section of Kashi earth dam

For some small earth dams located in the counties, their design had obvious defects without proper control. For instance, the Kashi earth dam is of inclined core (silty clay loam) with sand gravel shells, the designers wanted to have an impermeable barrier and they put on two layers of plastic membrane with thickness 0.2 mm not on the surface but on the bed (Fig. 2). It made the whole core under water saturated and decreased the friction angle from  $34^\circ$  to  $23^\circ$ . It undoubtedly was the reason of the surface slide (Fig. 6). This is also an example of liquefaction of the core and shell.

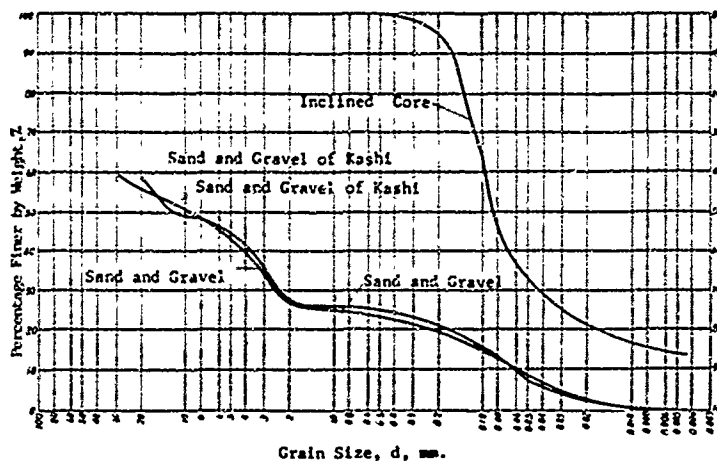
Fig. 7 Grain size distribution curves of Kashi earth dam

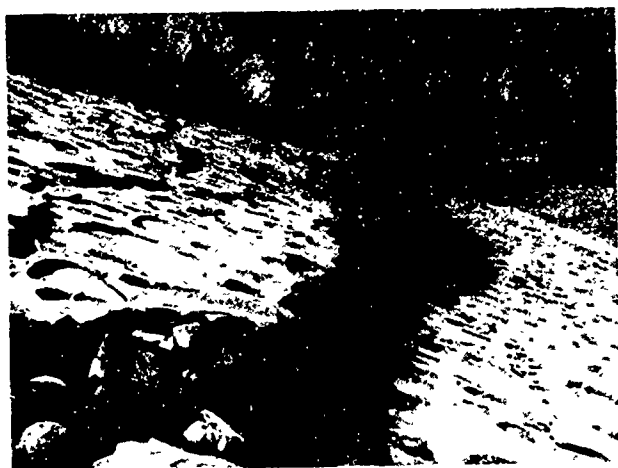
Fig. 8 Photograph of longitudinal cracks on the upstream slope of Kashi earth dam

There were 6 longitudinal cracks, 2 of them were on the crest, 4 on the upstream slope (Fig. 8, 9). The horizontal displacements were 20-30 cm, the vertical displacements were 10-40 cm. 11 transverse cracks were discovered near abutments. The maximum width was 5 cm.

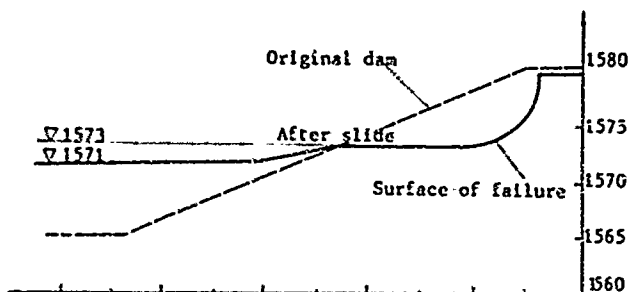
Fig. 10 Cross section of slide on the upstream slope of Kashi earth dam at 0+250 after earthquakes

The slide of upstream slope 0+250 section show in Fig. 10, 11.

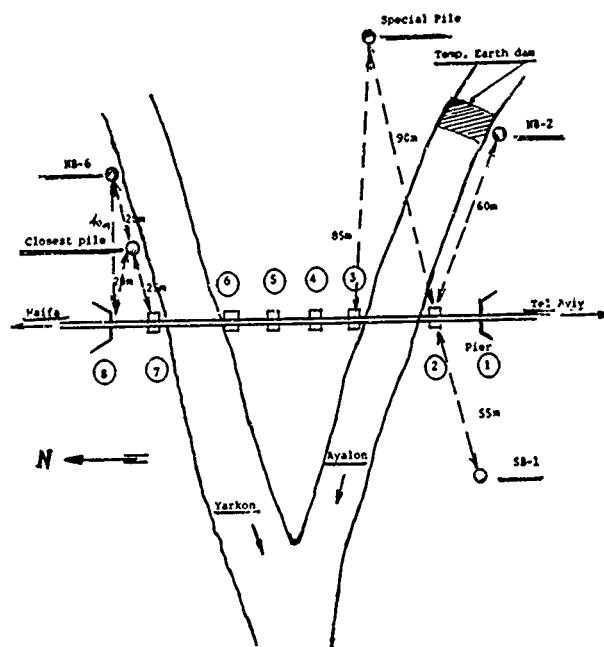
Fig. 1 - Layout of the railway bridge and location of the test piles.

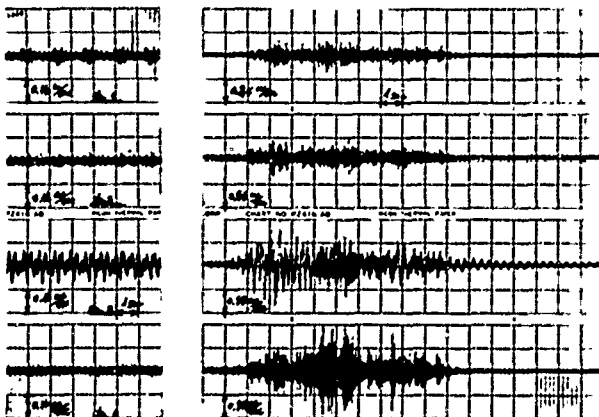
Fig. 3 - Vibration Measurements at pier 2:  
Test 1 (left); Test 2 (right).

It is interesting to note also, according to Tests 1 and 2, that the vibration at the pier head was amplified by a factor of two, as compared with the measurements at the foot of the same pier. This behaviour occurred during both hammer operation and train passage as well (Fig. 3). Vibrations at the pier heads 2 and 3 decreased with increasing depth of the driven pile, as can be seen in Fig. 4, mainly in the transverse direction. In the present case, the ground had a uniform composition in

Analysis has shown that the peak transverse amplitude at pier head obtained during the passage of a rapid train were at least 10 times higher than during pile driving operation. Considering an amplification factor of 2 of the vibration at the pier head (see Fig. 3,a), the ground vibration at the pier foot should be half of it, or  $\pm 0.209\text{mm}$ . This result is in good agreement with amplitude limits of foundation block, which do not cause any damage to the structure, as mentioned in the British Code of Practice, i.e.  $\pm 0.200\text{mm}$ , up to 20 Hz. Other codes (e.g. DIN 4150), specify a limit velocity

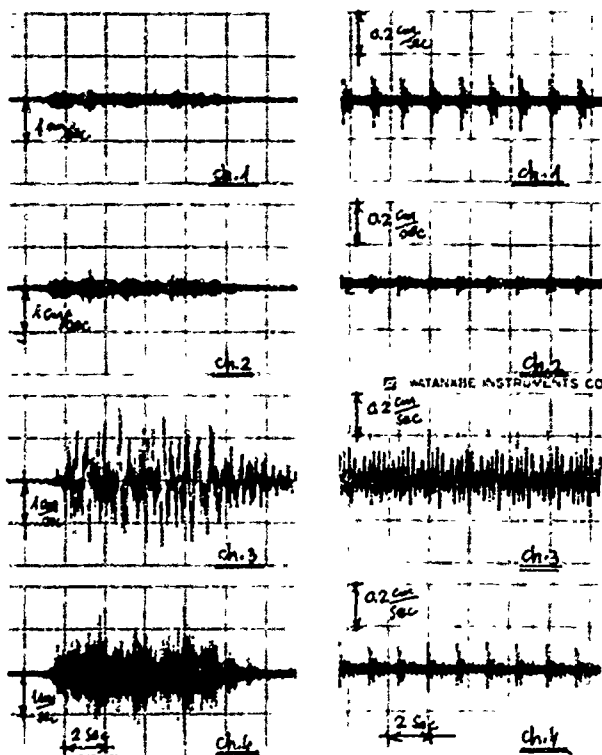
Fig. 5 - Measurements during passage of a rapid train (Test 10).

Fig. 6 - Measurements during driving of the closest pile (30m) (Test 14).

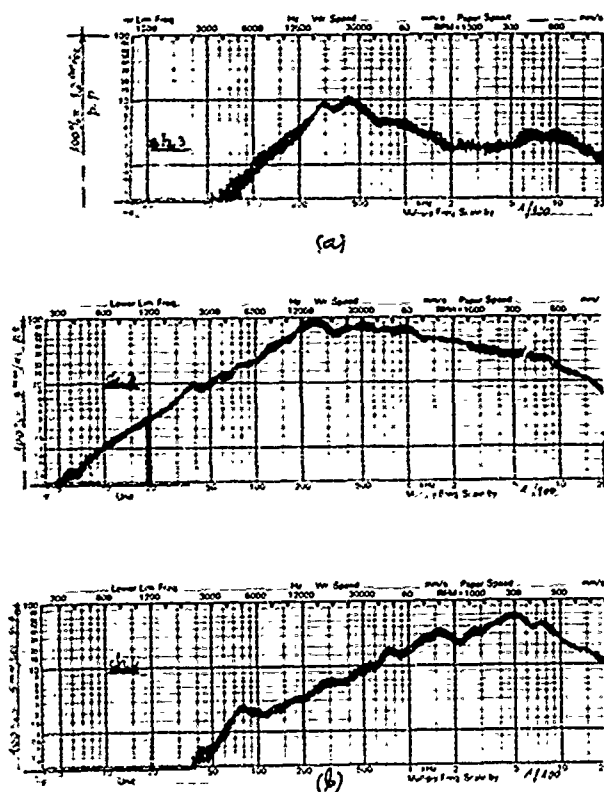
Fig. 8 - Velocity spectrum (third octave):  
a) Test 1, channel 3: driving of pile SB-1,  
b) Test 2, channels 3,4: passage of train.

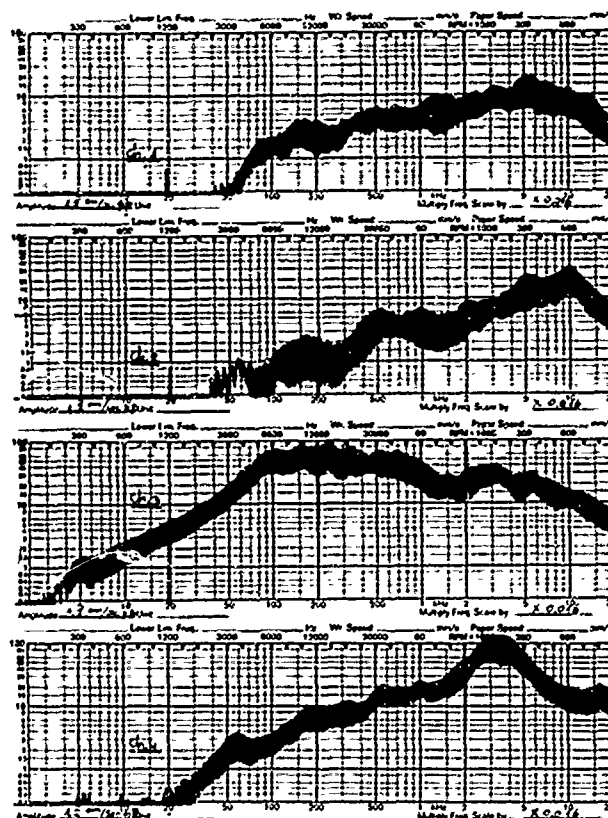
Fig. 9 - Velocity spectrum (third octave):  
Test 10, channels 1 to 4: passage  
of a rapid train.

Spectrum analysis (third octave) of the measured velocities yielded the frequencies of the vibrations and permitted the calculation of the pier head displacement amplitudes (Table 2). In most cases the spectrum had only one peak velocity. However, that of Test 10, Channel 3 (Fig. 9), was rather a type of "plateau", and could be interpreted to show a peak at 4 Hz. In this particular case, a lower velocity, at a lower frequency of 1.6 Hz, yielded displacement of  $\pm 0.418\text{mm}$  instead of  $\pm 0.215\text{mm}$ , as computed from the peak velocity.

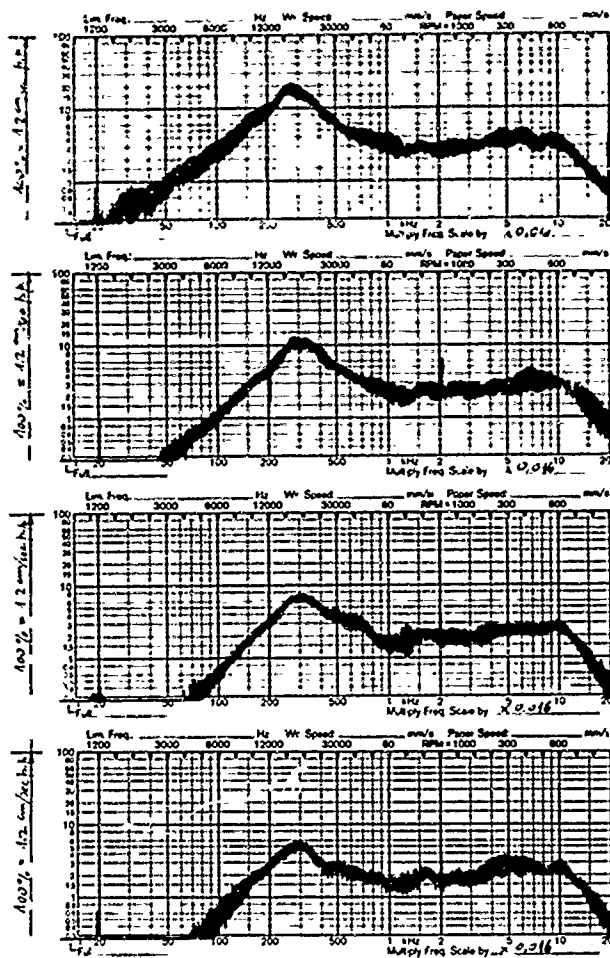
Fig. 10 - Velocity spectrum (third octave), Tests 6 to 9, channel 3: driving of special pile, at various depths.
